Left Front Bumper Popped Out Near Headlight and Fender

YEAR(S)	MODEL(S)	ADDITIONAL INFORMATION
2022 - 2024	IS500	WMI(s): JTH

Some 2022 – 2024 model year IS 500 vehicles may exhibit a left front (driver's side) front bumper popped out near the fender and headlight area. Follow the Repair Procedure in this bulletin to address this condition.

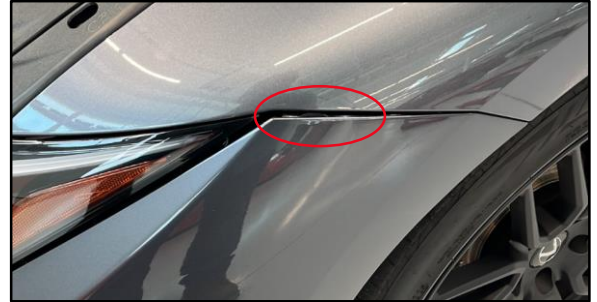
1. Confirm the condition exists.
Does the vehicle exhibit the driver's side front bumper popped out near the fender and headlight area as shown in Figure 1?
 - **YES** — Continue to step 2.
 - **NO** — This bulletin does NOT apply. Continue diagnosis using the applicable Repair Manual.

Figure 2. Vehicle Exhibiting Condition

2. Remove the front bumper assembly and place it on a bench.
Refer to TIS, applicable model and model year Repair Manual:
 - [2022 – 2024](#) IS 500:
Vehicle Exterior – Exterior Panels / Trim – Front Bumper (for Standard) – Removal

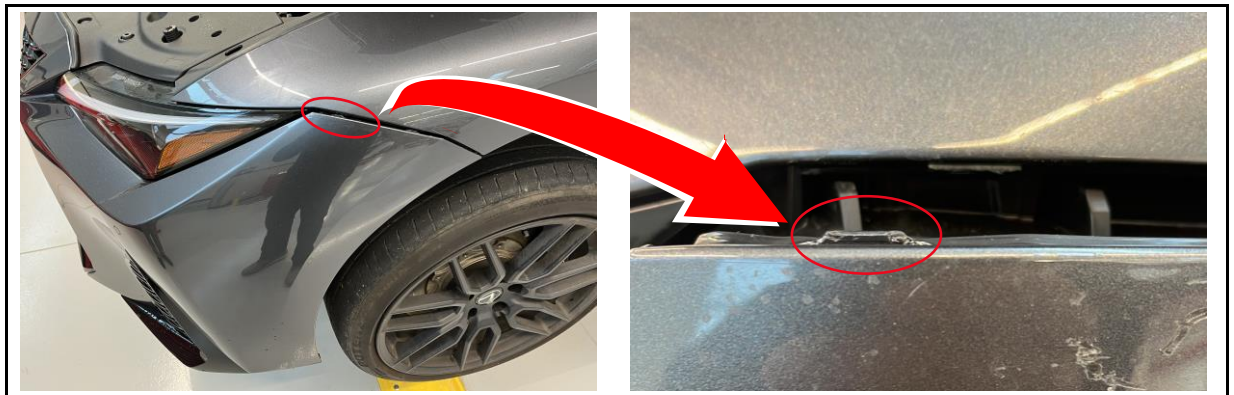
Figure 3. Tab Before Adjustment

3. On the outer bumper tabs, with your fingers, apply pressure to bring the front tab up into its original position in the order shown in the figures below.

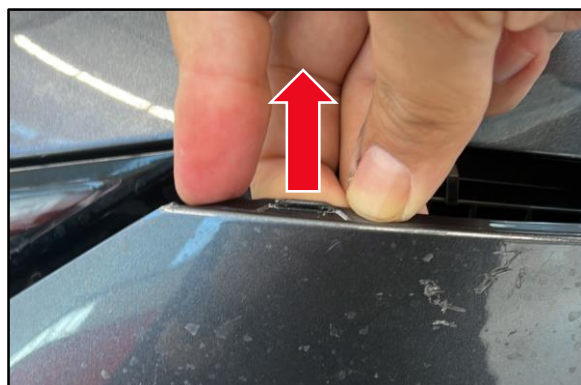
Figure 4. Tab During Adjustment

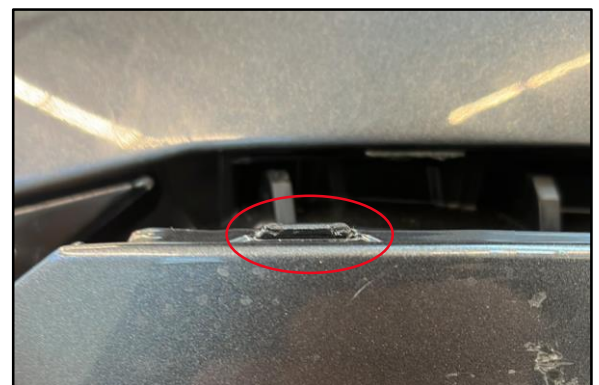
Figure 5. Tab After Adjustment

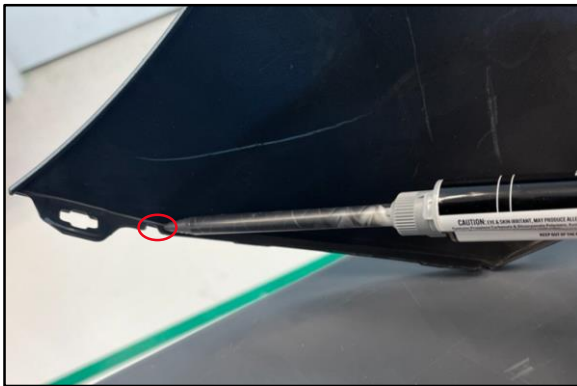
Figure 8. Start Point

- With the static mixer installed on the epoxy syringe, apply a steady 1 mm diameter bead of epoxy along the inner bend on both the left-hand and right-hand side of the bumper as shown below.

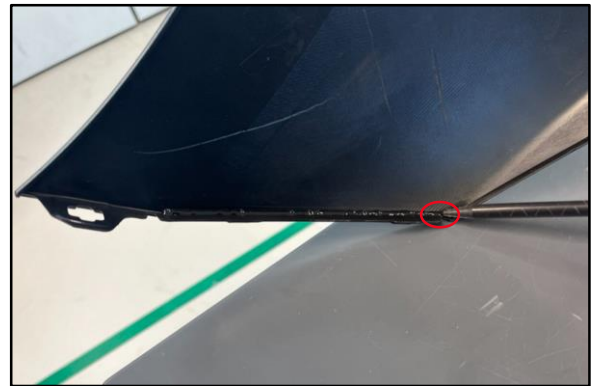
Figure 9. End Point

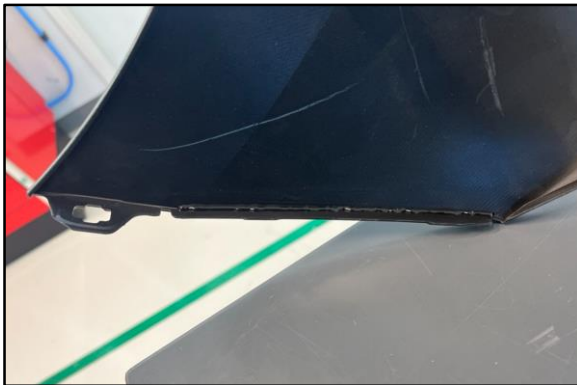
Figure 10. Left-hand Side Bead Applied

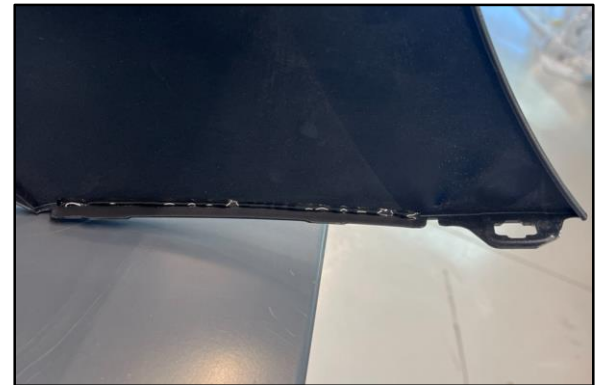
Figure 11. Right-hand Side Bead Applied

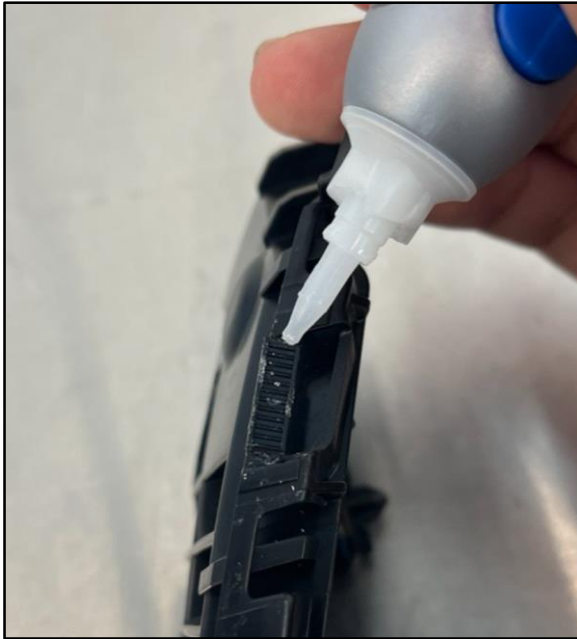
Figure 17. Top Bead Location

12. Add a small bead of super glue gel to both ends of the strip as shown below.

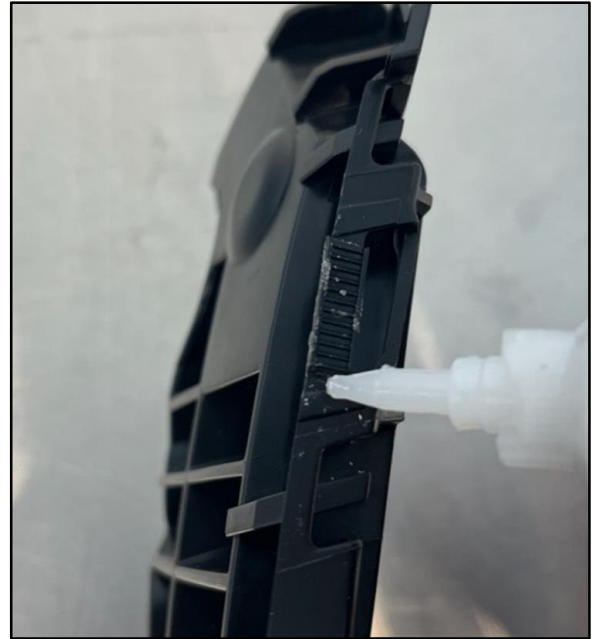
Figure 18. Bottom Bead Location
